## Tips to avoid VIA-T reading errors

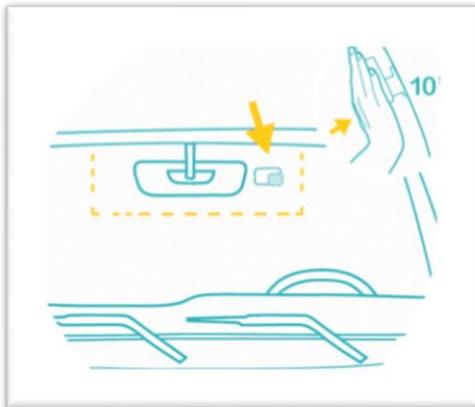
#### - Correct positioning of the device in the vehicle:

To avoid reading errors, the device must be placed in the central part of the windscreen in a position where it can be read by the toll antenna. Some vehicles are equipped with athermal windscreens that impede communication between the VIA-T and the toll antenna. In this type of vehicle there is a shaded area, just above the rear-view mirror, where the device works correctly. If it is placed in another part of the windscreen, there is no guarantee that it will work properly.

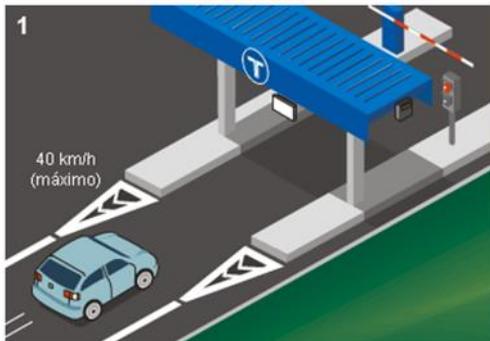
The car approaches at 40 km / hour (max.)

For the VIA-T device to work properly, the vehicle must approach the toll gate in a lane prepared to read the device (marked with a T) at a maximum speed of 40 km / hour. When the reading has been completed, the device beeps and the barrier is raised.

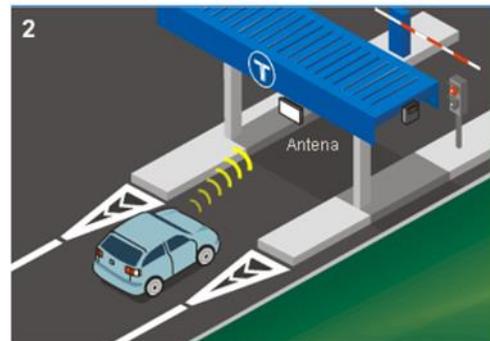
The system identifies the owner of the device

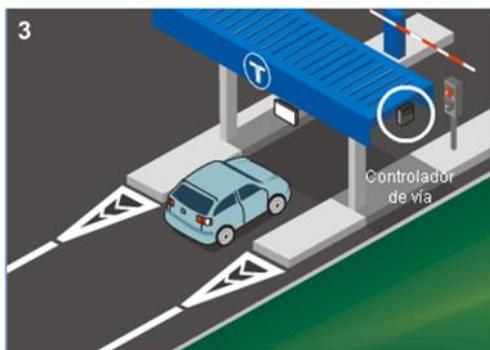
The device is read

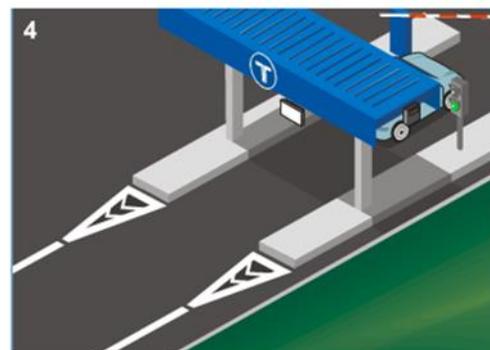
The device beeps, the traffic light changes to green and the barrier is opened
